DESIGN MEMORANDUM
ON
CAPE COD CANAL, MASSACHUSETTS
EAST ENTRANCE
REHABILITATION OF BREAKWATER

U. S. ARMY ENGINEER DIVISION, NEW ENGLAND
CORPS OF ENGINEERS
WALTHAM, MASSACHUSETTS
16 MAY 1962

DESIGN MEMORANDUM ON CAPE COD CANAL,
MASSACHUSETTS - EAST ENTRANCE -
REHABILITATION OF BREAKWATER

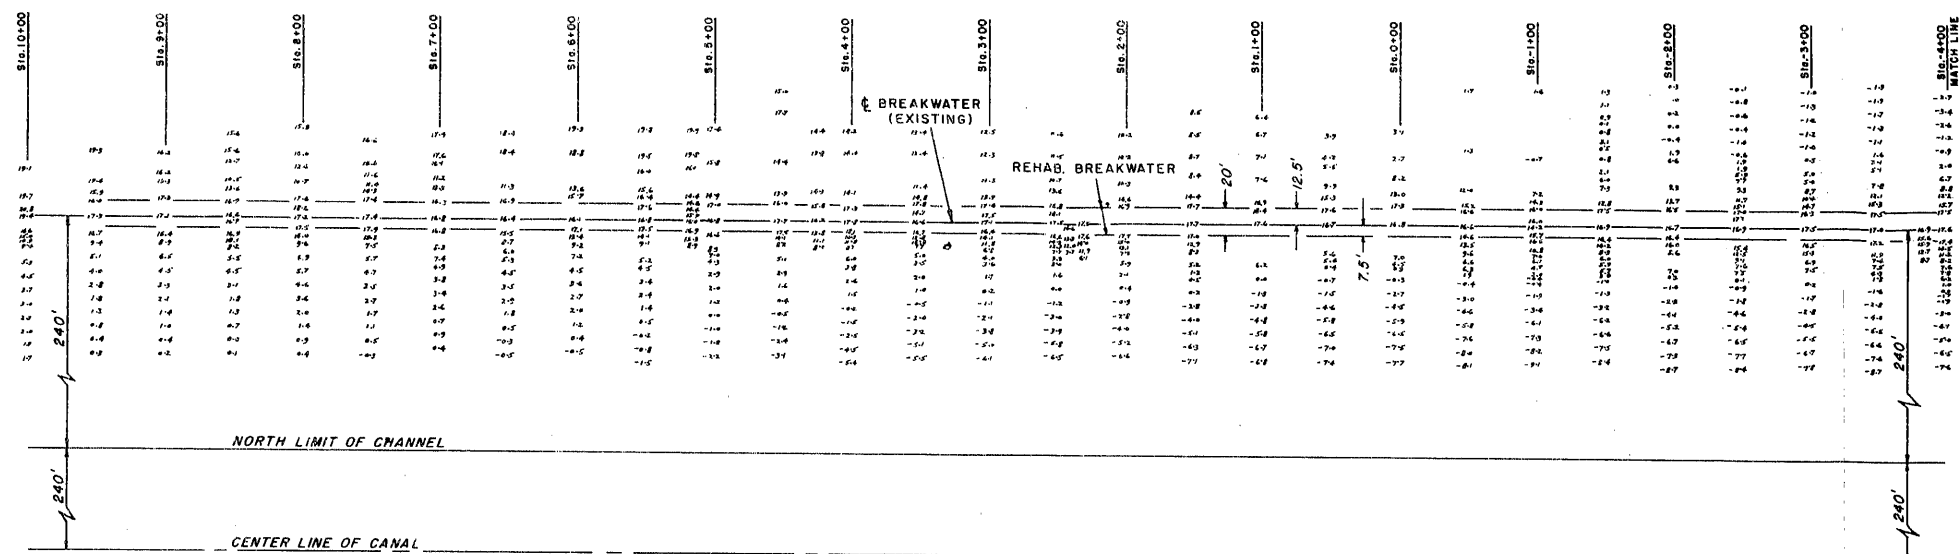
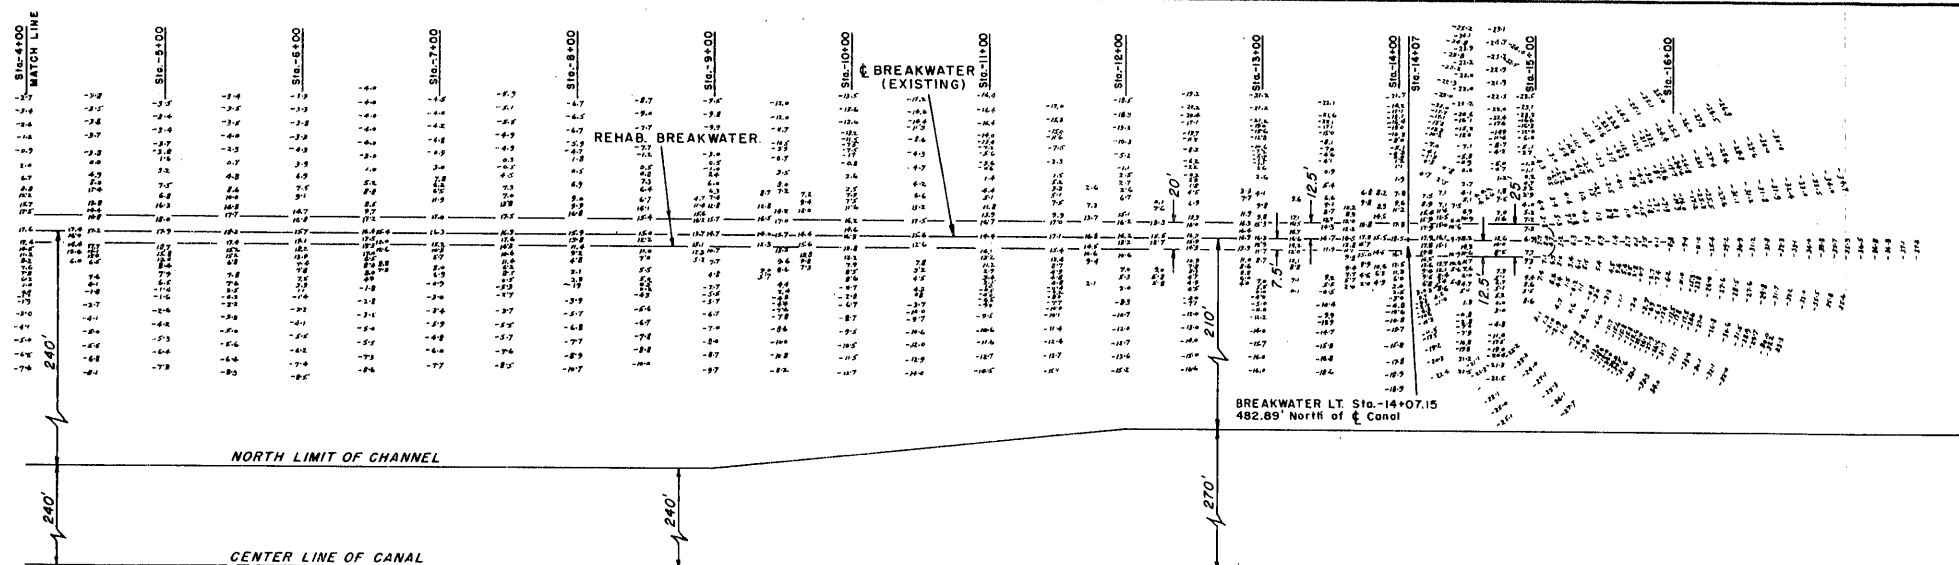
PLAN - BREAKWATER
SCALE 1"=50'

13. Surveys of the jetty and breakwater were made in the period 27 December 1961 to 5 February 1962 when profiles, cross sections, and soundings were taken. The surveys show substantial damage at the breakwater tip and moderate damage along the outer part of the breakwater trunk. An inspection made in April 1962 found no change from conditions when the survey was made.

30. The project plan consists of rehabilitation of the existing breakwater at the eastern entrance of the Cape Cod Canal by placing stone riprap to restore and strengthen it as described in paragraph 26 above and shown on the attached plans and cross sections.

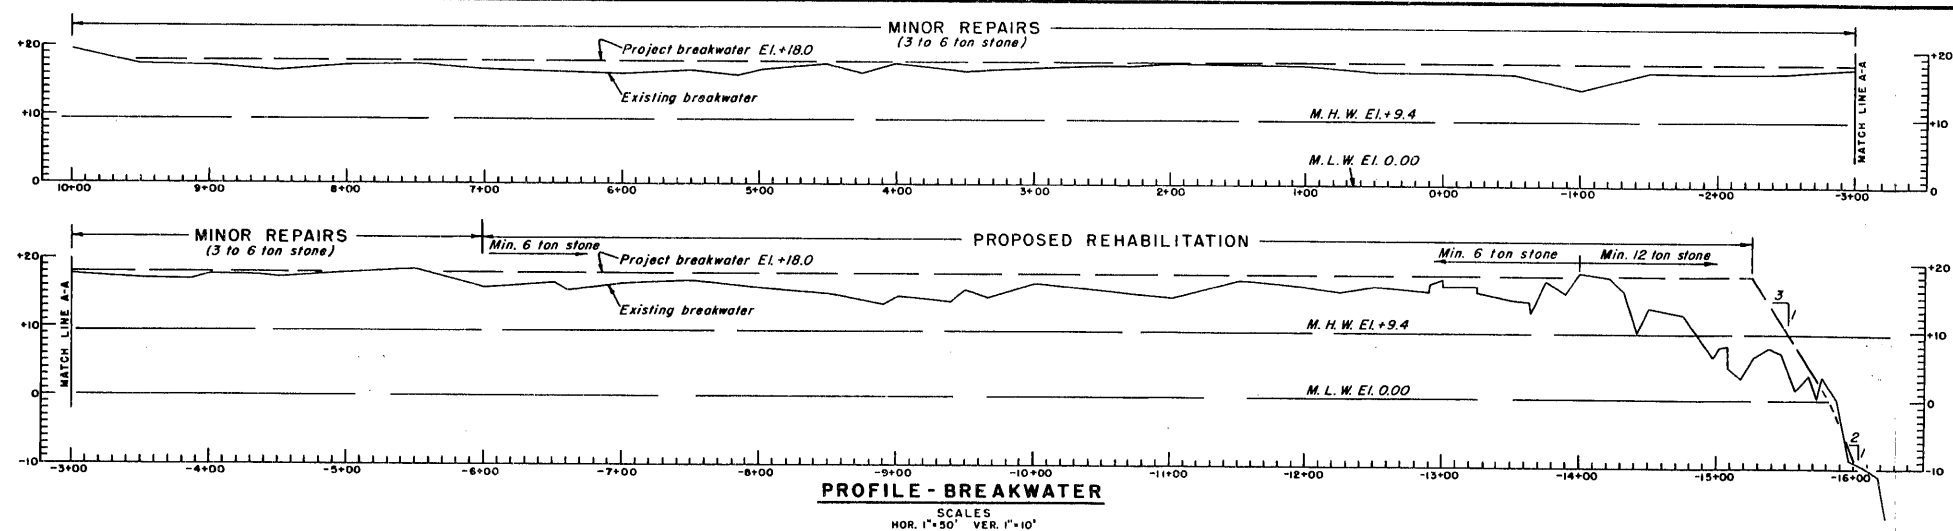
PROFILE - BREAKWATER
SCALE
HOR. 1"=50' VER. 1"=10'

16. Suitability of Design as Constructed - Structural. - The breakwater was completed in 1913, and in the 49 years since has been generally stable. The tip, which is exposed to deep water waves, has been flattened from a slope of 1 on 2 to a slope of about 1 on 7. The trunk on the canal side has been flattened from 1 on 1 to about 1 on 2.5. This damage is evidence that the original design was not adequate to prevent damage. It should be noted that the original design was sufficient to fulfill the purpose of the structure for 50 years. It is considered that an improved design to strengthen the top and the outer 700 feet of the trunk would assure at least another 50 years of life with minimum maintenance.

<u>Crest Elevation</u>	<u>Crest Width</u>	<u>Side Slopes</u>	<u>Stone Size</u>
Breakwater				
Head	+18' M.L.W.	25'	1 on 3	12-ton
Trunk: Station				
-6+00 to head	+18' M.L.W.	20'	1 on 2	6-ton
+10+00 to -6+00	Reshape existing structure			3- to 6-ton
